# CASE STUDY

Carbontech Case study 008  
6"x 4" Hydrocarbon drain line

Case Study Number  
CTCS:008

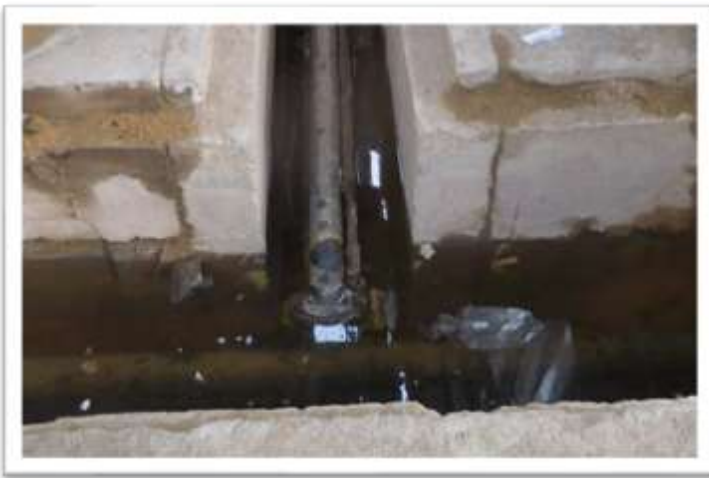
Severe external corrosion detected on a hydrocarbon drain line.

Figure 1: Active leak caused submersion of the pipe and flange.

Further deterioration to piping could lead to loss of primary containment resulting in high risk of fire or injury from Hydrocarbons. Flange bolts have deteriorated to an extent of nuts fusing to the flanges and adding further concerns to the piping integrity over and above the line operating with pipe thicknesses below the designed T-min.

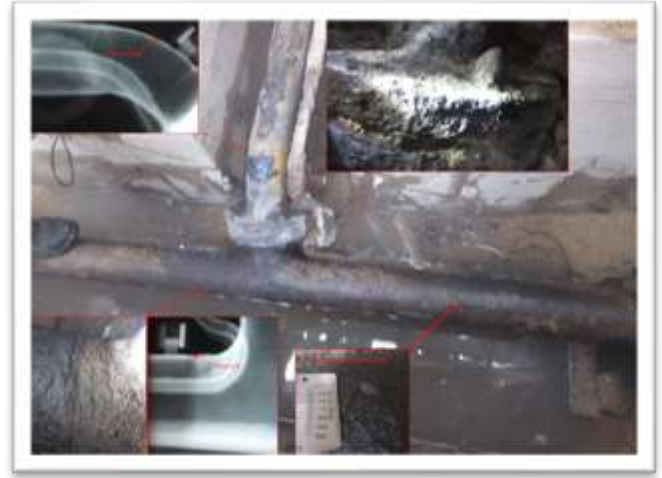
Figure 2: Severe external corrosion of the pipe and flange.

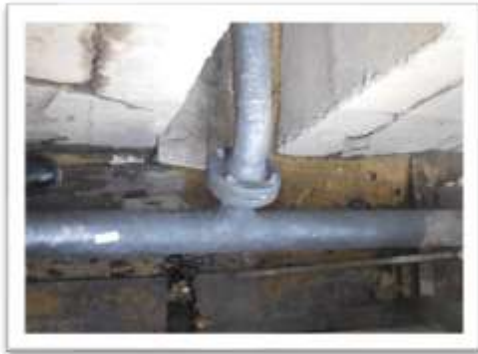
Figure 3: SSPC SP3 surface preparation of the elbow tee with flange.

Simultaneous operations were required to keep the channel dry at all times as it would fill up within 2 hours, technicians did a surface preparation under SCBA in the case of creating any through holes in the pipe due to the thin wall thickness. Once prepared according to SSPC.SP3 the pipe was wrapped but external heating was required to get a sufficient cure on the resin. This required a habitat be built, the use of a Tioga heater to keep the temperature to a sufficient heat for cure as well as the water continually being drained. fuses to the profiled flanges.

Surface Preparation achieved: SSPC.SP3  
Product used: Revowrap 185  
Engineering calculations: ISO TS 24817  
Layers used: 4 layers  
Post cured: Habit with external heaters

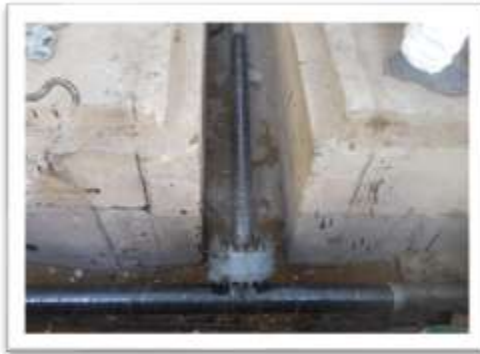
Figure 4: Installed wrap

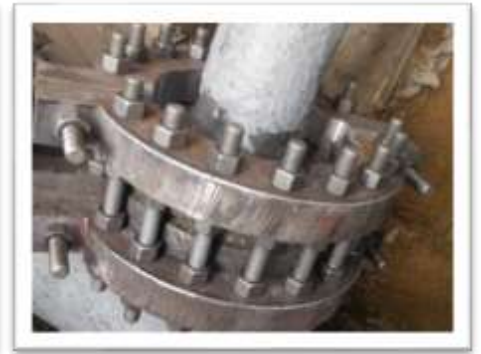
Figure 5: Bolted flange clamp prior wrap

It is the refinery policy not to wrap over flanges and once the pipe was wrapped the flange would be the next problematic area, Beruseal designed a strongback system to keep the system in place in the event of bolt failure of the flange, a surface prep was done on the entire flange and the area between the flange was profiled with Revofill.
