Carbontech Case study 009
12" Flange Wrap on GRP fire water line

PROJECT DETAILS

| | Repair Summary Firewater Line | Operating Pressure 8 Bar | |

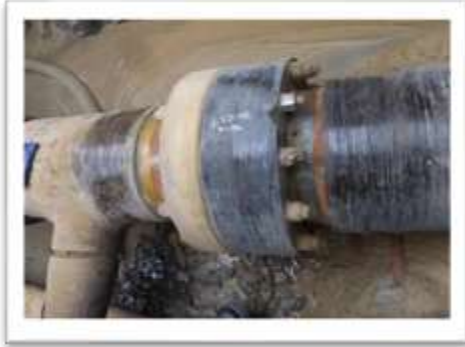
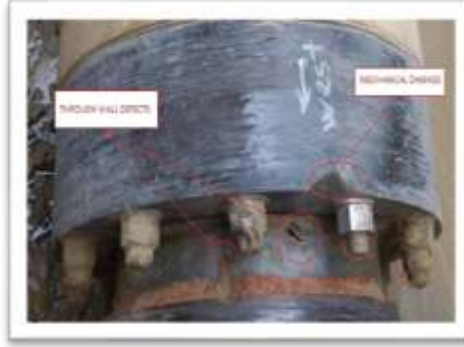
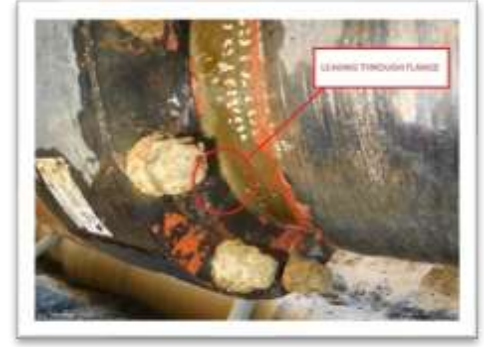
Through wall defects and mechanical damage of piping and flanges

Through wall defects created the leaks in pipeline and it was further discovered that the integrity of the gasket between the flanges was questionable, since another leak was present at the flange connection. The line was used for firefighting water, and therefore played an integral role in the safety systems of the plant. The option to remove the bolts and change the gasket was rejected due to concerns of causing further damage to the glass reinforced epoxy system. The criticality of the line was high due to it being a safety system, therefore, an urgent sealing solution was required.

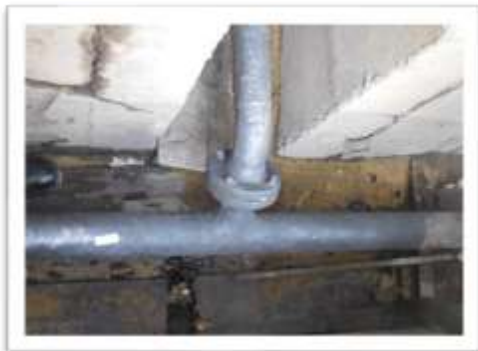
Figure 3: SSPC SP3 surface preparation of the elbow tee with flange.

1). The line was isolated and surface preparation was performed using sand paper and acetone - stronger surface preparation methods cannot be used on glass reinforced epoxy. The bolts and nuts were cleaned using MBX bristle blaster. The defects were then covered with Revoprep and smoothed. The Revoprep was also applied to crevices between the flange and pipe to ensure a good seal. the second option was then selected as the most efficient sealing solution. The efforts of the Carbontech Engineering team, lead to the development of an installation procedure to ensure a qualified repair for 5 years

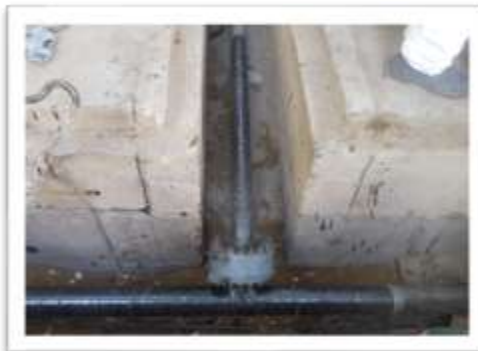
Figure 4: Installed wrap

The composite repair was successful and was completed in a period of four days. The upstream valve was removed to ensure that the line was completely isolated, and a Tioga heating system was used to ensure that the pipeline and its components were completely dry during all stages of the repair. The line was put back into service successfully.

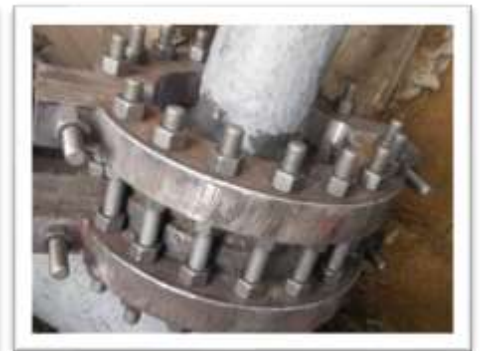
Figure 5: Bolted flange clamp prior wrap
