CASE STUDY

Carbontech Case study 011
30" Flare Gas line Repair

Case Study Number
CTCS:011

Repair Summary
30" Flare Gas Line.

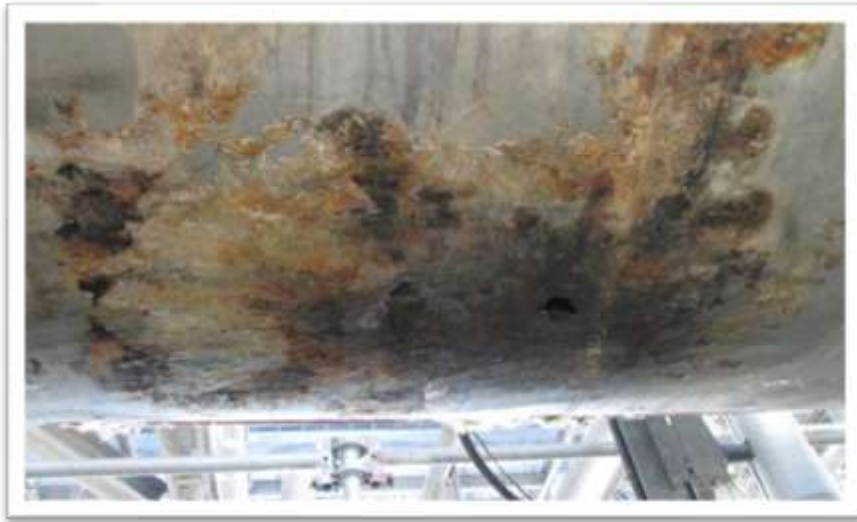
A through hole due to internal corrosion was noted on a 30" Flare line. PAUT corrosion mapping was done on the line and reviewed that the line also suffered severe pitting. A minimum thickness of 7.7mm was also recorded from an original nominal thickness of 12.7mm.

Figure 1: Through wall defect

Continued pitting corrosion results in larger holes scattered across the affected area and this causes the pipe to weaken around the corroded area. This will result in the pipe losing its structural integrity and may cause sudden failure of the pipe. Furthermore, leaking process could result in major fire and environmental hazards.

A rectangular plate (with threaded hole in the middle) was rolled to outside diameter as the original pipe. The pipe was cleaned to a bare metal finish. After smearing the hole's periphery with Revofill, the plate was placed over the hole and some Revofill was applied around the plate to stop the gas from leaking through the sides of the plate but only through the threaded hole. Metal cable ties were used to secure the metal plate while allowing the Revofill to set. Cable ties were removed and the grub screw was screwed into the threaded hole to stop the leak. Carbontech installed 8 layers of carbon fiber composite wrap that is engineered to ASME PCC2 2015. The wrap was designed to a worst-case scenario to allow for up to a 40mm through defect failure.

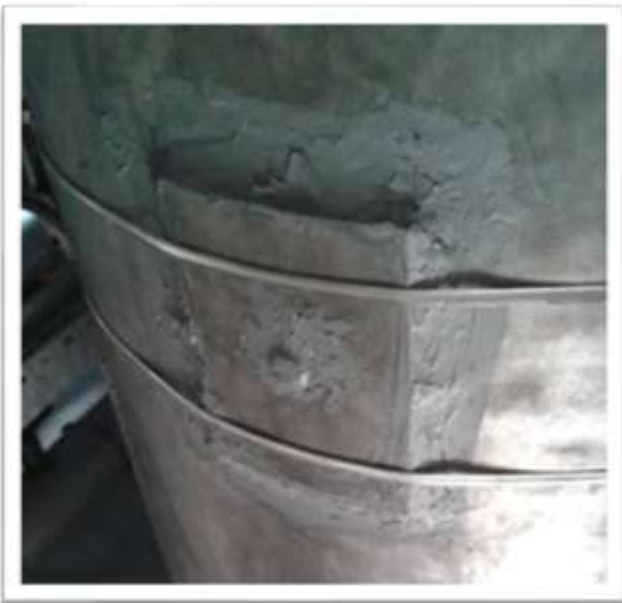
Figure 4: Patch secured with Revofill

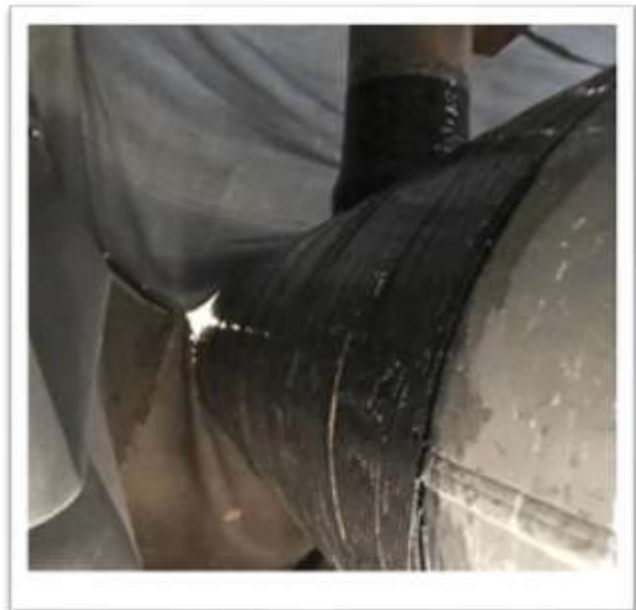
Figure 5: Completed Wrap

Surface Preparation achieved: SSPC3

Product used: Revowrap 185

Engineering calculations: ASME PCC2

Layers used: 8 layers

Post cured: External using Habitat

The use of Revofill and a rectangular plate helped to temporarily stop the leak resulting in a successful carbon fiber wrap that restored integrity until the next planned turnaround where the flare line was planned to be replaced.
