Carbontech Case study 012
6" Sewer Line Repair

Repair Summary
6" Sewer Line

Client
Shell & BP (Sapref)

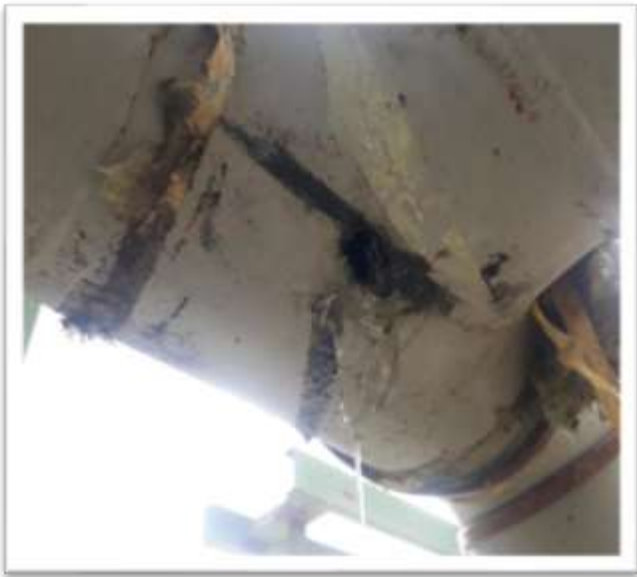
Figure 1: Leak Location

Operations reported a leak on Domestic Sewage Piping discharge line *Figure 1*. The leak is located on the Tee bottom, the through-wall damage is Ø27 mm. *Figure 2*. The pipe spool consists of three series-connected tees. UT scan was performed to determine method of repair and it was found that minimum thickness adjacent to leak was 5.5mm while T-nom is 7.1 mm. The minimum allowable structural thickness of the piping is 3.8mm per ANSI. The possible cause of the damage is bacteriological corrosion or corrosion under deposits (internal corrosion).
