Carbontech Case study 013
6" Cooling water line with external condensation

| | Case Study Number CTCS:013 | Design Pressure 6.2 Bar | |
| | Repair Summary 6" Cooling water | Operating Pressure 4.9 Bar | |

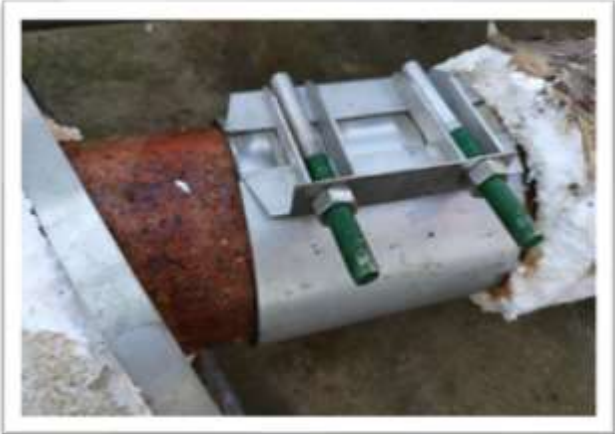
Multiple leaking areas were detected on an aging 6" cooling water line. The leaks developed from pitting due to corrosion under insulation. The main culprit being the pipe continuously forming condensate underneath the insulation creating the perfect conditions for corrosion.

Figure 1: Failed clamp Repair 1

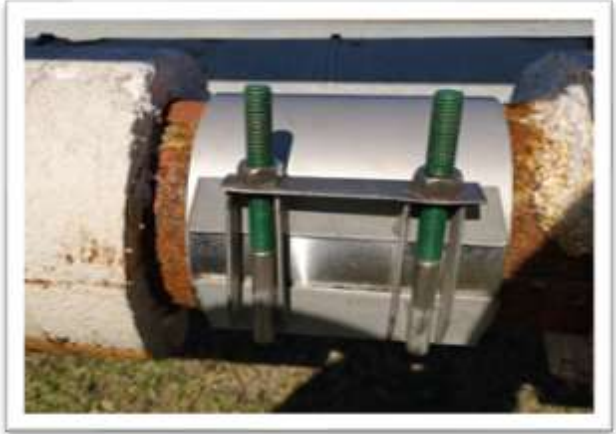
Figure 2: Failed clamp repair 2

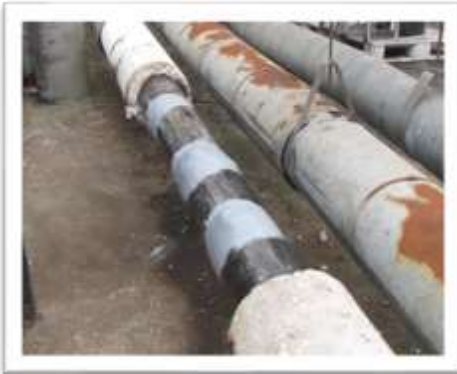
Figure 3: Leaks clamped with straps and profiled with Revofill

The leaking pinhole had to be arrested, however as we removed the insulation Carbontech technicians found multiple leaking pinholes within the external pitting. These were all arrested by using a specialized soft rubber and strap. The line due to differential temperature was constantly wet from condensation. Revowrap Resin systems are Hydrophobic in nature and will dispel any condensate forming on the surface posing no threat to the repair system however an unnoticed leak will build up pressure underneath the wrap area during cure, this meant the technicians had to make sure there was no additional leaks from the pipe.

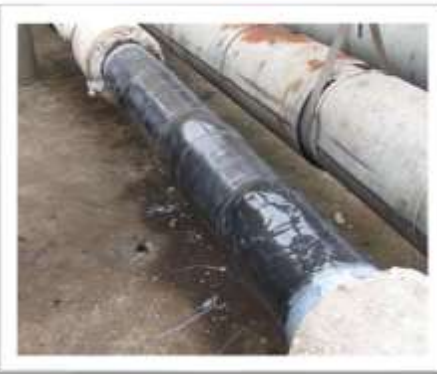
Figure 4: Completed wrap

Surface Preparation achieved: SA2.5

Product used: Revowrap 1110

Engineering calculations: ASME PCC2

Layers used: 4 layers

Post cured: Not Required - however cure time was 48 hours due to the cold pipe temperatures

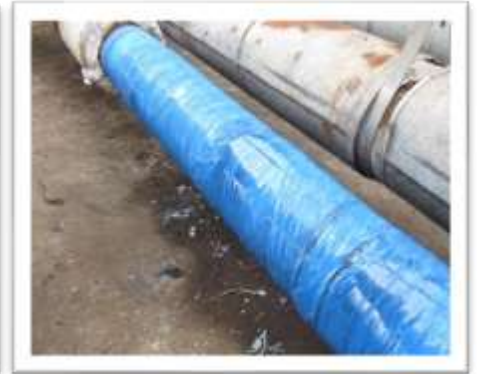
Figure 5: Revostretch applied to consolidate wrap

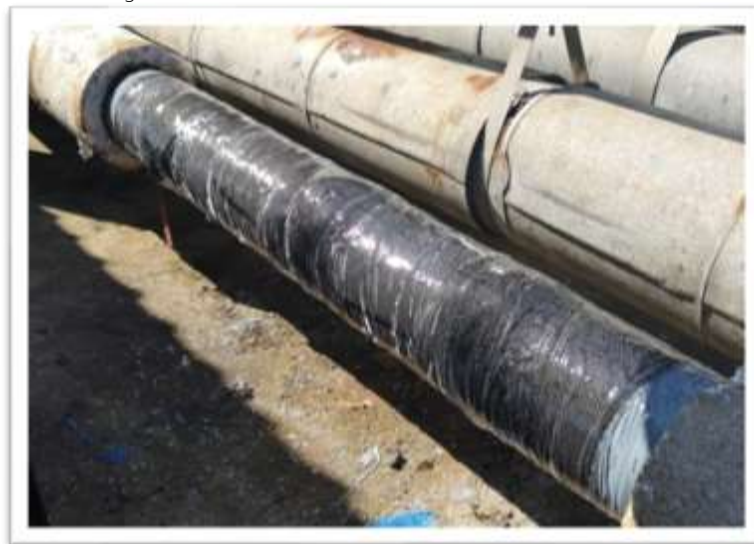
Figure 6: The Revostretch was removed after cure was reached
