Carbontech Case study 014

48" Raw water leak

Case Study Number CTCS:014	Design Pressure 25 Bar

Repair Summary 48" Raw water	Operating Pressure 17 Bar

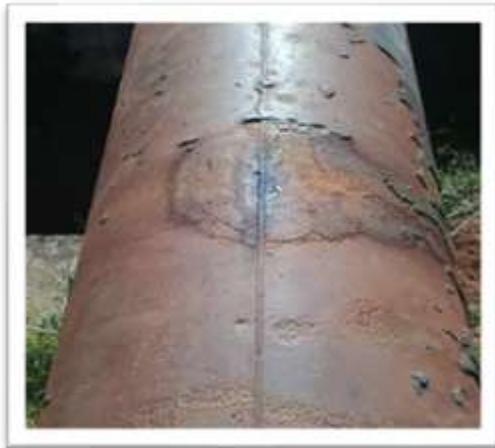
Figure 1:

A water leak was reported on a 48" pipe (see *Figure 1&2*). After closely examining the leaking area, it was noted that the leaking water was coming out of the defected longitudinal weld that runs along the length of the pipe. Severe external corrosion was also noted around the leaking area. This might have been caused by the leaking service coming into contact with metal pipe therefore causing corrosion over time. Figure 1 also reveals signs of pitting corrosion.

Defected longitudinal weld is a huge structural concern in pipes since circumferential forces(stresses) are usually greater than axial forces(stresses). In pipe design, longitudinal welds must withstand circumferential forces and therefore a defected longitudinal weld poses greater risk on structural integrity of the pipe

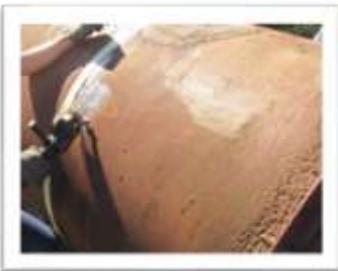
Figure 3: Bristle blasting

Using bristle blaster, sand paper and paint stripper(eco-friendly), the pipe was cleaned to a bare metal finish (see **Figure 3&4** below).

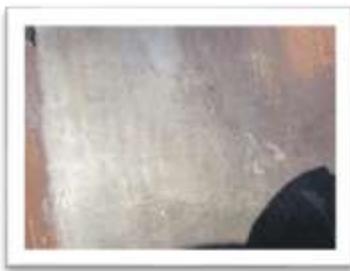
Figure 4: SA 2.5 surface standard

After pipe cleaning, the surface profile was examined using testex tape to ensure the surface finish falls within acceptable standard. The pipe was then cleaned with acetone to remove any undesirable contaminants from the metal surface. **Figure 5** shows the pipe surface after cleaning with acetone.

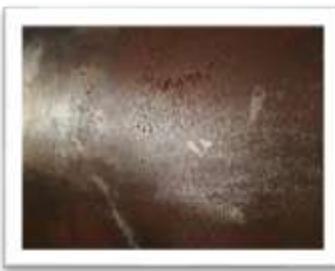
Figure 5: Pitting

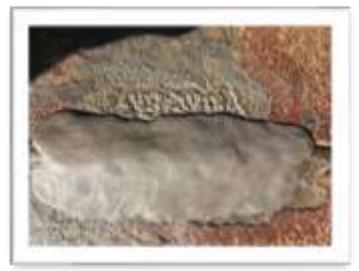
Figure 6: Revofill repair of leak

The defect weld area was covered and profiled with quick-setting putty (see **Figure 6** above) to fill in the holes left by pitting corrosion and also to completely stop the water from escaping through the defect before the pipe was wrapped. Although the line was isolated, small quantities of water were still present on the defected weld hence the use of quick-setting putty to completely eliminate any water leaks. The profiled putty also helped in achieving a smooth wrap over the defected weld.

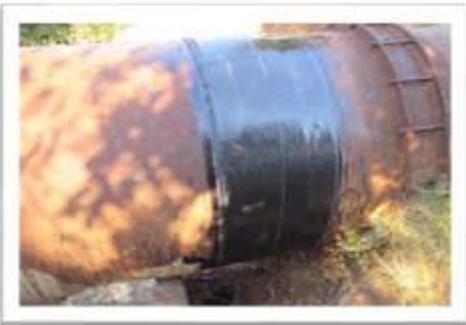
Figure 7: Completed repair

Revowrap, engineered to ASME PCC-2 2015, was applied over the defected weld and cleaned pipe surface to successfully complete the installation (see **Figures 7&8**). 12 layers of composite wrap were installed on this repair.

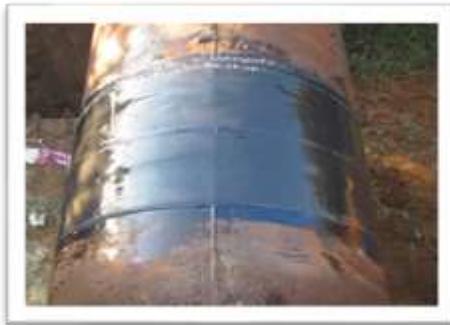
Figure 8: Completed repair

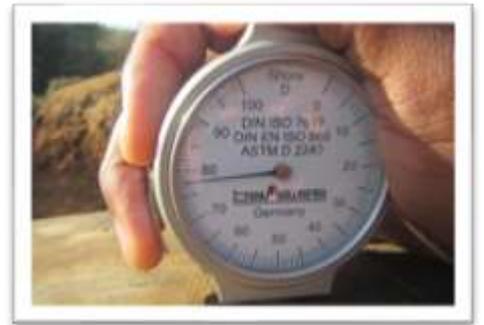
Figure 9: Hardness test

The Revofill putty was key to achieving a successful repair since it completely eliminated water leaks therefore enabling the wrap to be installed without any concerns. It is vital for the wrap to cure before operating the line back to full service and the Shore D hardness test results confirmed that the wrap was cured successfully. After switching the line to full service, no leaks were noted concluding a successful repair
