Carbontech Case study 015

4" Fire water Leak

Case Study Number  
CTCS:015

Repair Summary  
4" Fire water repair

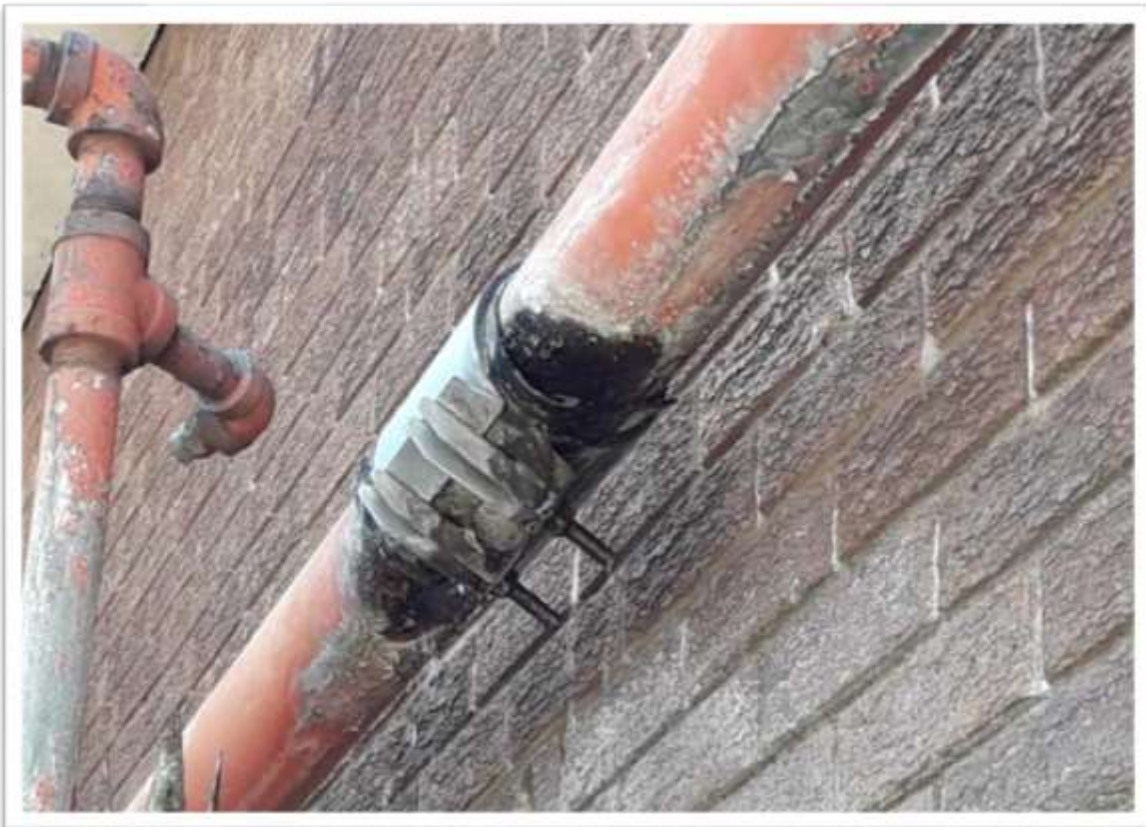
Internal corrosion on a 4" Fire Water line resulted in through wall corrosion (see Figure 1). Due to it being on the main Header off the fire Fighting water line, Isolation and replacement was not possible. A previous repair was attempted by a non-engineered sleeve clamp which was unsuccessful.

Figure 1: Failed sleeve clamp

An engineered clamp repair was also not a feasible option due to the pipe's proximity to the wall. Four layers of Composite carbon fiber, engineered to ASME PCC-2 2015, was applied over the defected areas to successfully complete the installation (see *Figure 4*). After 24 hours a full cure was achieved.

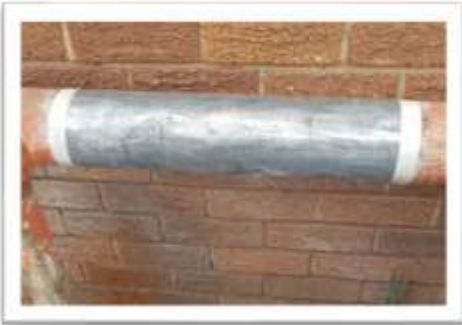
Figure 2: Surface prepared to SA2.5

Using a bristle blaster, the pipe was cleaned to a bare metal finish (see *Figure 2 & 3* below). After pipe cleaning, a Quickset Epoxy was used to arrest the leaking pinhole, thereafter the surface profile was examined using Testex tape to ensure the surface finish falls within acceptable standard. The pipe was then cleaned with acetone to remove any undesirable contaminants from the metal surface. Four layers of Composite carbon fiber, engineered to ASME PCC-2 2015, was applied over the defected areas to successfully complete the installation (see *Figure 4*). After 24 hours a full cure was achieved

Surface Preparation achieved: SA2.5  
Product used: Revowrap 110  
Engineering calculations: ASME PCC2  
Layers used: 4 layers  
Post cured: Not Required

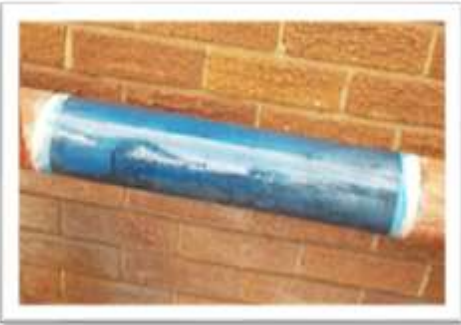
Figure 3: Pipe is Primed for wrap

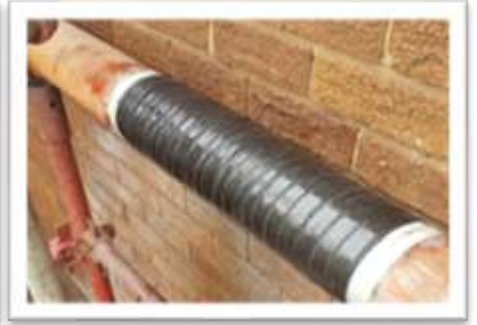
Figure 4: Completed wrap

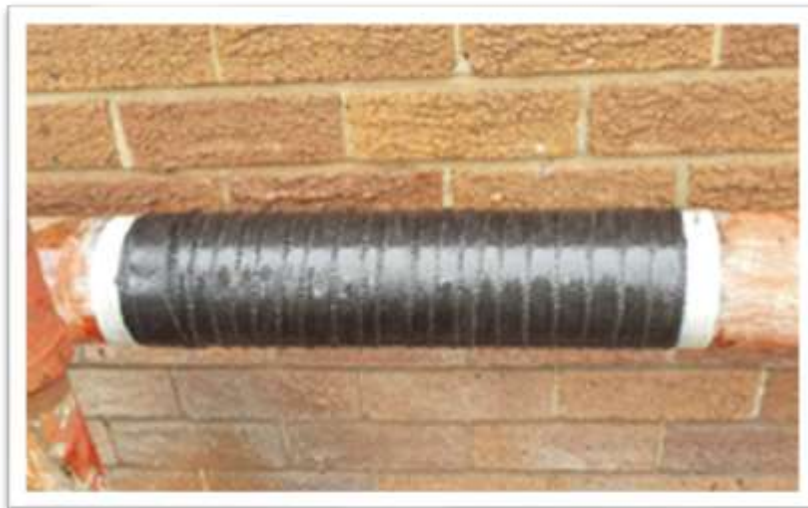
Figure 5: Completed wrap

A successful repair was completed and the pipeline could run as per normal specifications.
