CASE STUDY

Carbontech Case study 016
16" Pipe support Repair

Case Study Number
CTCS:016

Repair Summary
16" Pipe support

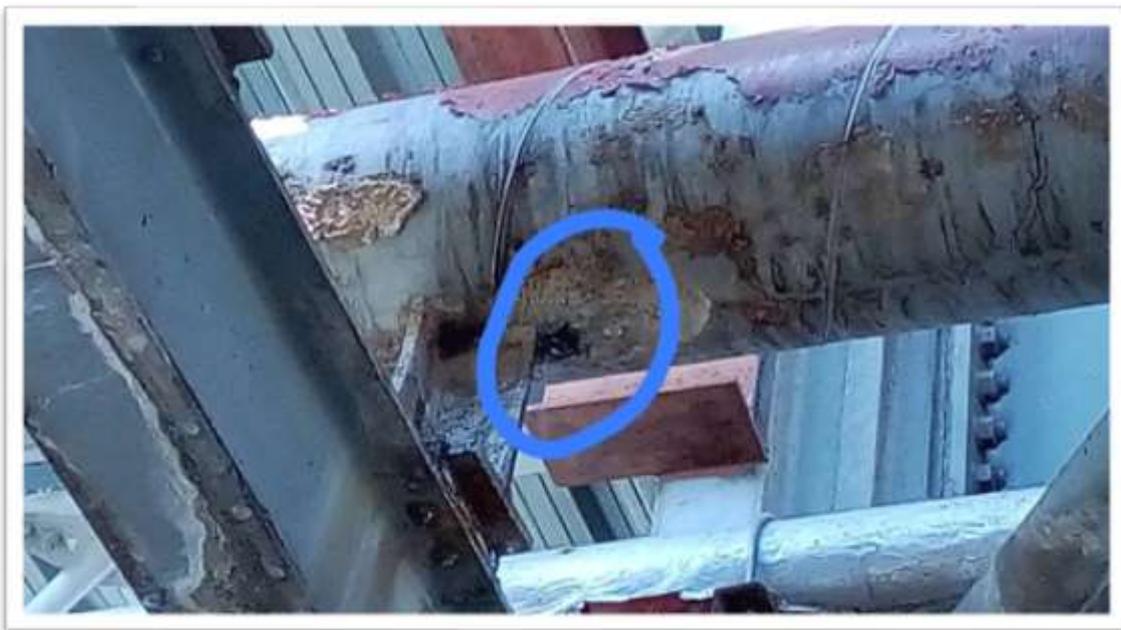
Figure 1:

Physical inspection revealed a pinhole on the 6 o'clock position next the pipe's support (see *Figure 1*). The pipe had also suffered from internal corrosion.

Further operation of piping with severe internal corrosion with an existing pinhole poses the risk of collapsing the pipe therefore causing loss of its containment and possible injuries to nearby personnel
