Carbontech Case study 017
Wrapping over 2" Flange

Repair Summary
12" Flange Repair

Client
ESKOM

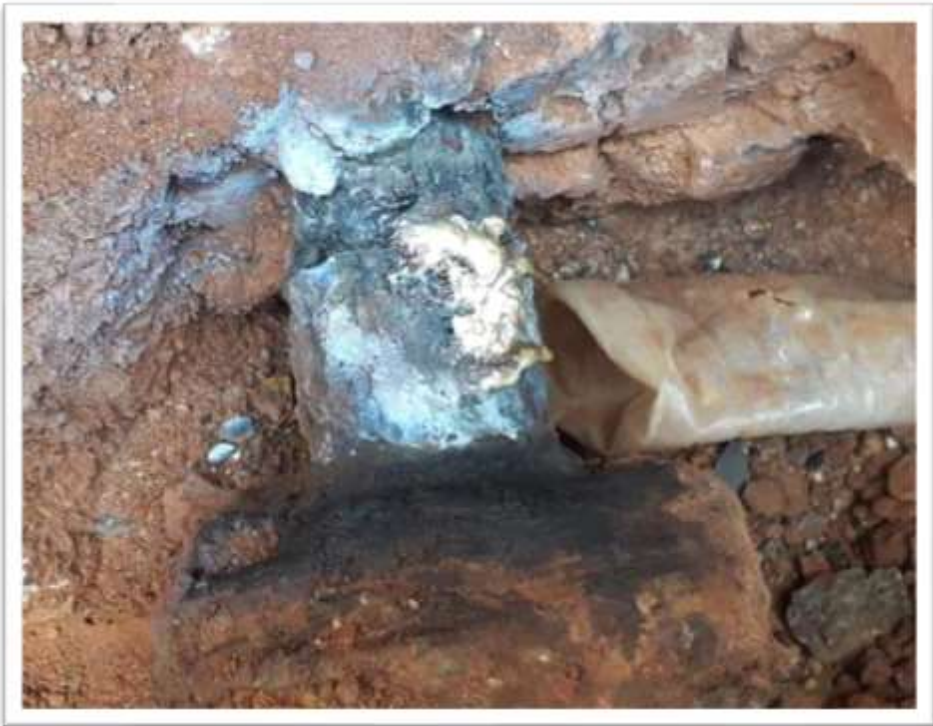
Figure 1:

External Corrosion from deteriorated pipe coating of a 1.5" buried flange led to a through wall defect on the piping system. (See Fig 1&2)
