Carbontech Case study 019
Manhole Cover Repair (Vacuum Pressure)

Case Study Number
CTCS:019

Client
Illovo Sugar Mill

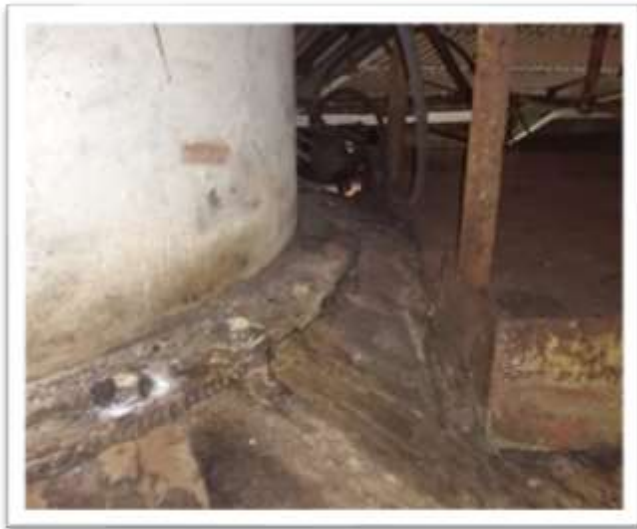
A leak was found on a Flanged joint of a vessel. The Vessel operates at Vacuum and periodically goes into a positive pressure resulting in leakage from the flanged joint (*see Figure 1 & 2*). The possible cause is due to ageing gasket of the vessels flange joint.

Figure 1: Leak on flanged area

The leaking flange negatively affects the operation of the vessel and with a permanent repair not in the scope of work further deterioration could be detrimental for the operation of the vessel. The pipe was isolated and a bristle blaster was used to clean the pipe to a bare metal finish. After pipe cleaning, the surface profile was examined using Testex tape to ensure the surface finish falls within acceptable standard. The area was then cleaned with acetone to remove any undesirable contaminants from the metal surface as well as removing all the silicone sealant previously used to attempt to fix the leak. The step up between the flange and vessel was profiled to create a smooth transition for the compositematerial.

Axial strips of Revowrap were laid all around the periphery of the flange with a 50% overlap thus creating a 2layer repair (see Figure 3).

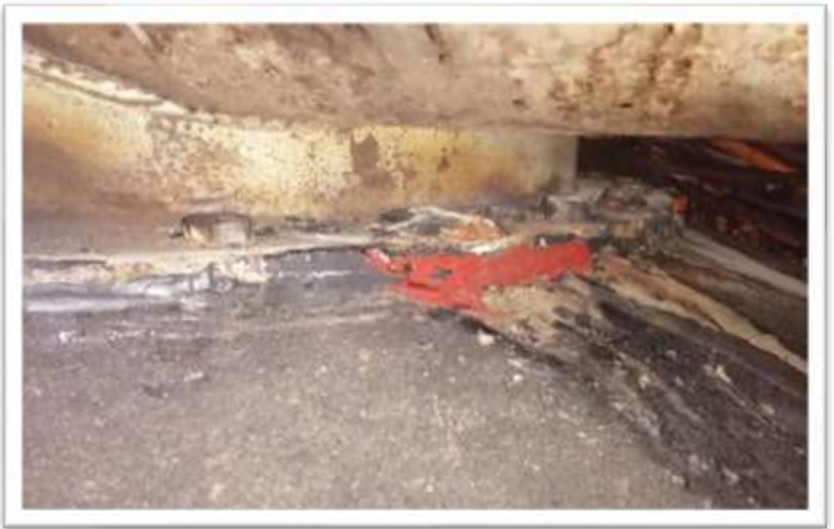
Figure 2: Leak on flanged area

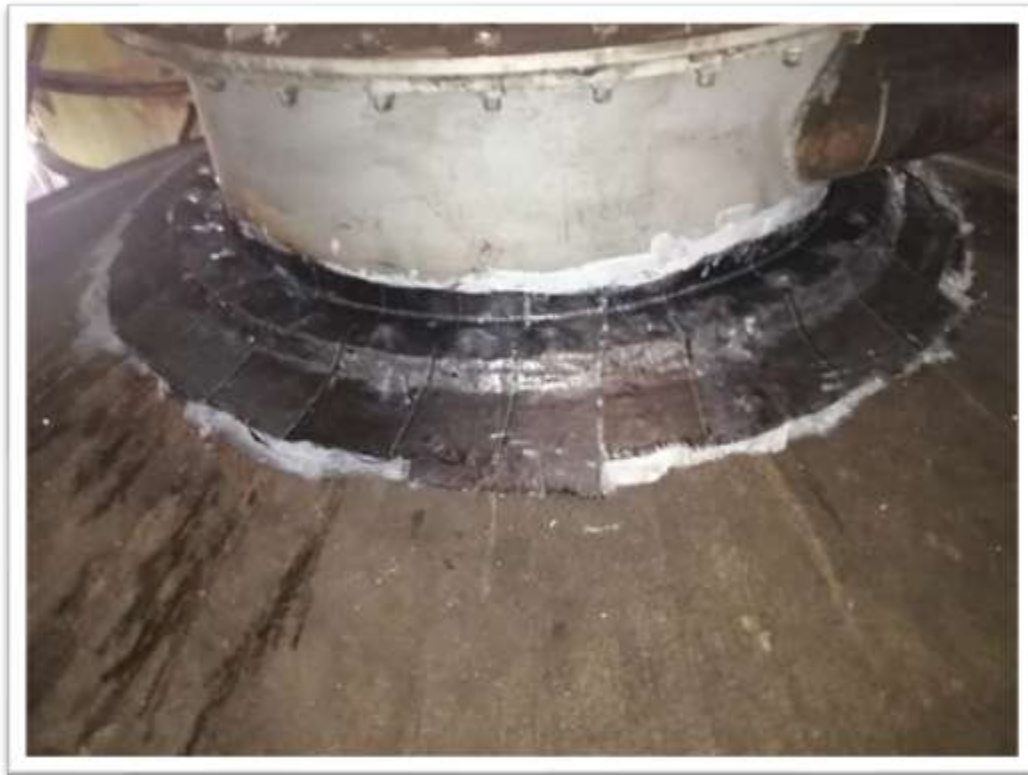
Figure 3: Completed Repair

Surface Preparation achieved: SA2.5

Product used: Revowrap 110

Layers used: 4 layers

Post cured: Not Required - Line temperature provided sufficient heat to cure the wrap.

A successful repair was achieved with full cure in 3hours due to the vessel operating at approximately 60 Degrees Celsius. This will allow the client to operate the vessel at normal capacity and leak free until the next planned turn around where the gasket can be replaced and repaired.
