# CASE STUDY

Carbontech Case study 020  
14" Elbow wrap with Re-enforced Strongback support

Case Study Number CTCS:020	Design Pressure 4 Bar	 
 	Repair Summary 14" Pipe wrap with Strongback	Operating Pressure 1.1 Bar	 
 	Client Refinery in Caspian Region	Design Temperature 160°C	 
 	Service Type Flexsorb	Operating Temperature 120°C	 
 	Line Size 2"	Base Material SA-516 Gr-70N	 
 	Line Class 150#

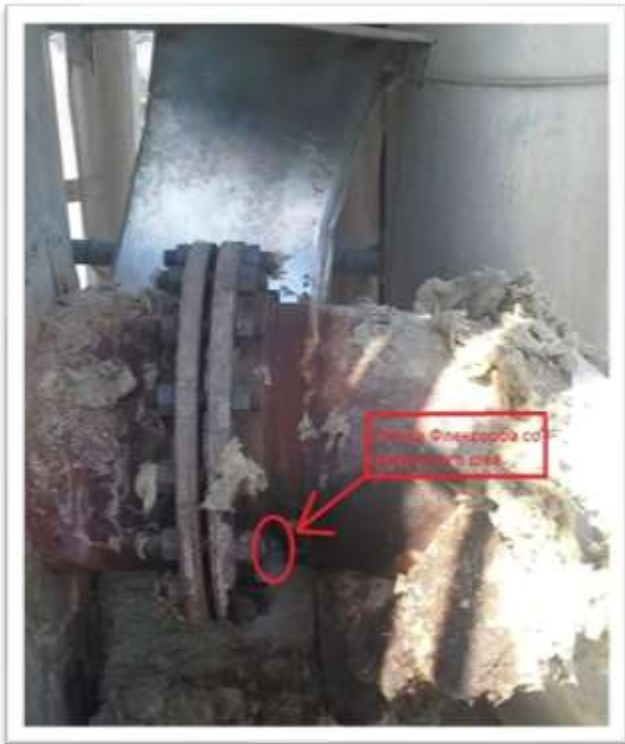
Figure 1:

The external inspection found the leak through a hole with a diameter less than 1mm on the piping straight section 40mm wide within the HAZ of the flange connection attachment weld. The leak was repaired temporarily for short- term period. Ultrasonic thickness test was performed within the leaking area and on the adjacent sections of the piping. Thickness of the damaged straight section was  $T = 3.6$  from  $4.6\text{mm}$ , thickness of the adjacent sections is  $T = 8.9$  from  $9.6\text{mm}$ .

Original thickness of the damaged pipe section did not meet minimum thickness requirements. Due to the piping being below specification further deterioration of piping could cause worsening leaks and ultimately failure. Operations of the piping with these non-conformities is not allowed.

By Using a patch and strap, the leak through the hole could temporarily be stopped to enable Carbontech to do a carbon fiber Composite repair to rebuild wall thickness and stop the leak (Composite wrap cannot be applied to leaking components unless leaks can be stopped). Due to the wall loss being concentrated next to the welding, Carbontech designed and manufactured a strongback restraint system that would be able to withstand total circumferential failure of the welding. The strongback was a multi part system that would restrain the elbow together with the complete assembled flange. An FEA analysis was performed to calculate stresses in the strongback components in the event of failure on the design pressure.

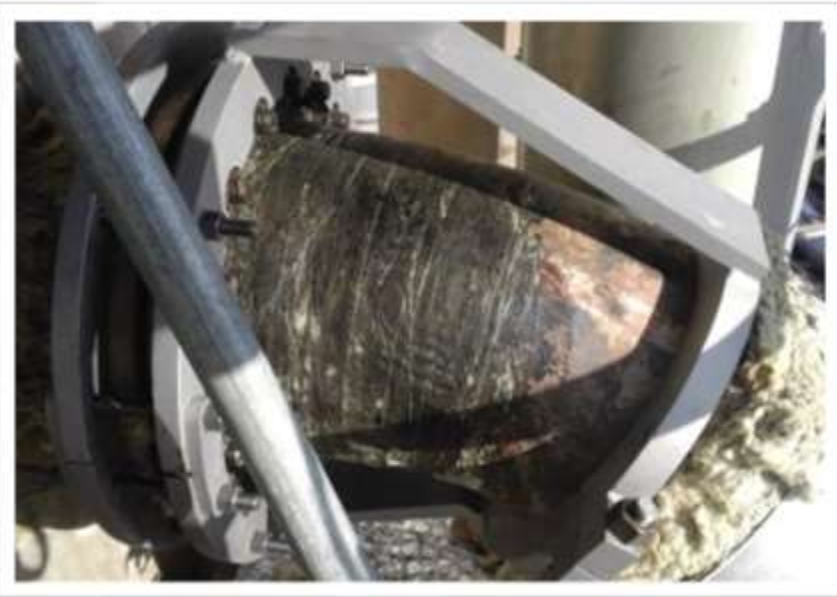
Figure 7: Wrap before Strongback

Surface Preparation achieved: SA2.5  
Product used: Revowrap 185  
Engineering calculations: ASME PCC2  
Layers used: 4 layers  
Post cured: Not Required - Line temperature provided sufficient heat to cure the wrap.
