Carbontech Case study 022  
Manhole cover repair

Case Study Number CT-CS:022	Design Pressure 10 BARg	 
 	Repair Summary Through wall patch	Operating Pressure Atmospheric	 
 	Client Shell & BP Refinery	Design Temperature -40°C to 50°C	 
 	Service Type Catalyst	Operating Temperature 30°C	 
 	Line Size N/A	Base Material SS316	 
 	Line Class N/A

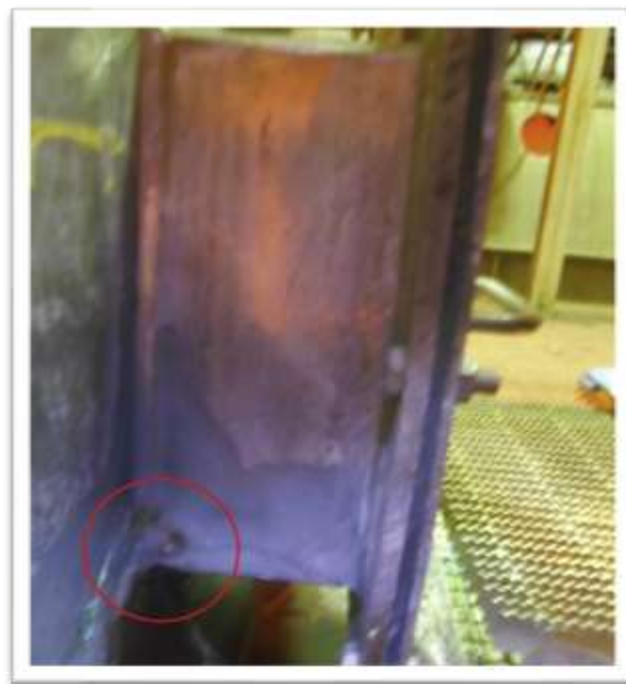
Multiple pitting discovered in manhole cover caused by internal corrosion.

Leak was detected and welding a patch repair would be challenging or not possible due to the location of the leak and the geometry of the manhole. If the leak was left unchecked it could compromise the asset leading to expensive replacements and shut downs

Figure 1 showing manhole with leak

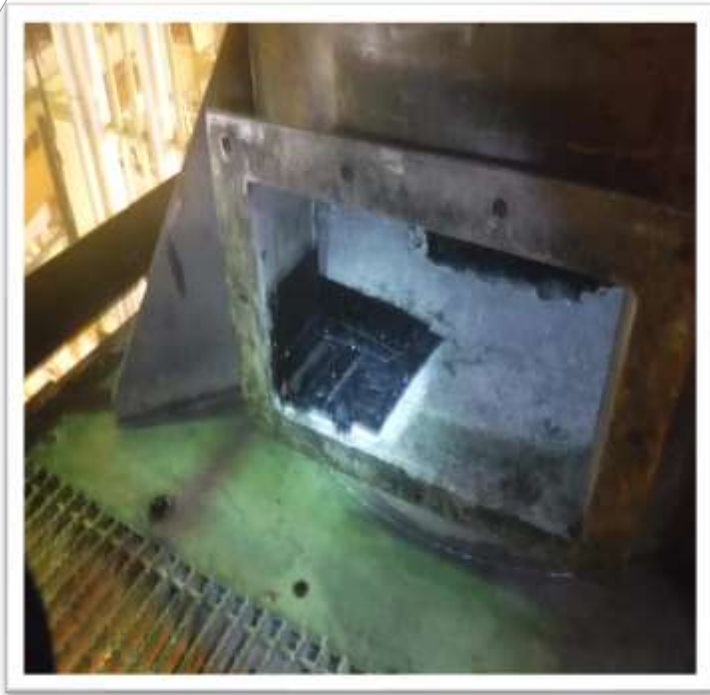
Figure2: Installed composite Internal wrap repair on manhole via patch repair.

Using a bristle blaster, the manhole surface area was cleaned to a bare metal finish. After surface cleaning, the surface profile was examined using Testex tape to ensure the surface finish falls within acceptable standard. The area was then cleaned with acetone to remove any undesirable contaminants from the metal surface.

The pinhole was plugged with quick setting putty to completely arrest the leak. Composite carbon fibre, engineered to ASME PCC-2 2018, was applied over the defected area to successfully complete the installation (see Figure 3). 4 layers of composite wrap were installed on this repair and to accelerate cure, hot air from a TIOGA space heater was directed over the repair area, this also aided in achieving cure with very low ambient temperatures from the winter season, after 24 hours a full cure was achieved

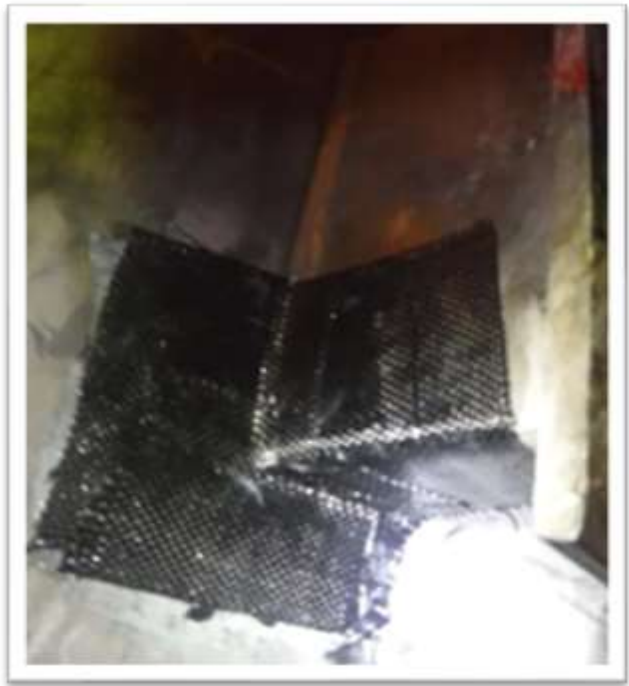
Figure 3: Installed composite External wrap repair on manhole via patch repair
