Carbontech Case study 024  
Gouge repair on 12" line

Case Study Number CTCS:024	Design Pressure 68.9 BARg

Repair Summary 300mm gouge repair	Operating Pressure 31 BAR

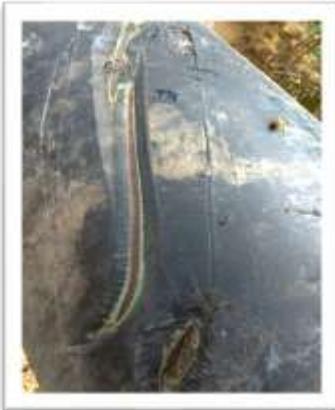
Fig 2: Removal of insulation layer

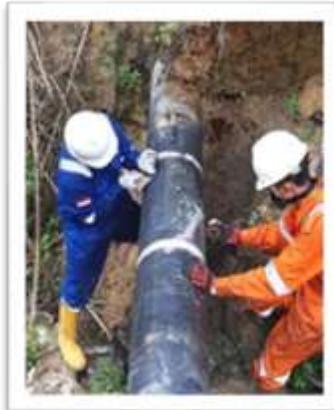
Fig 3: Surface Preparation with Bristle blaster

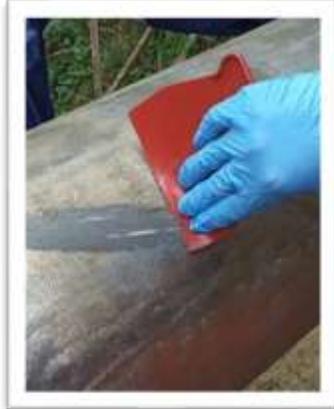
Fig 4: Tracing surface profile with Testex tape

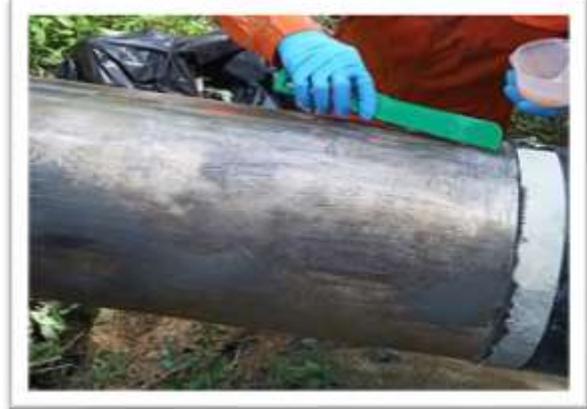
Fig 5: Filling the gouge damage with Revofill putty
