Carbontech Case study 025
N3 Nozzle repair

| | Case Study Number CTCS:025 | Design Pressure 20.68 Bar | |
| | Repair Summary External corrosion | Operating Pressure 0.2 BAR | |
| | Client Linde Gas Singapore Pte Ltd | Design Temperature 93°C | |

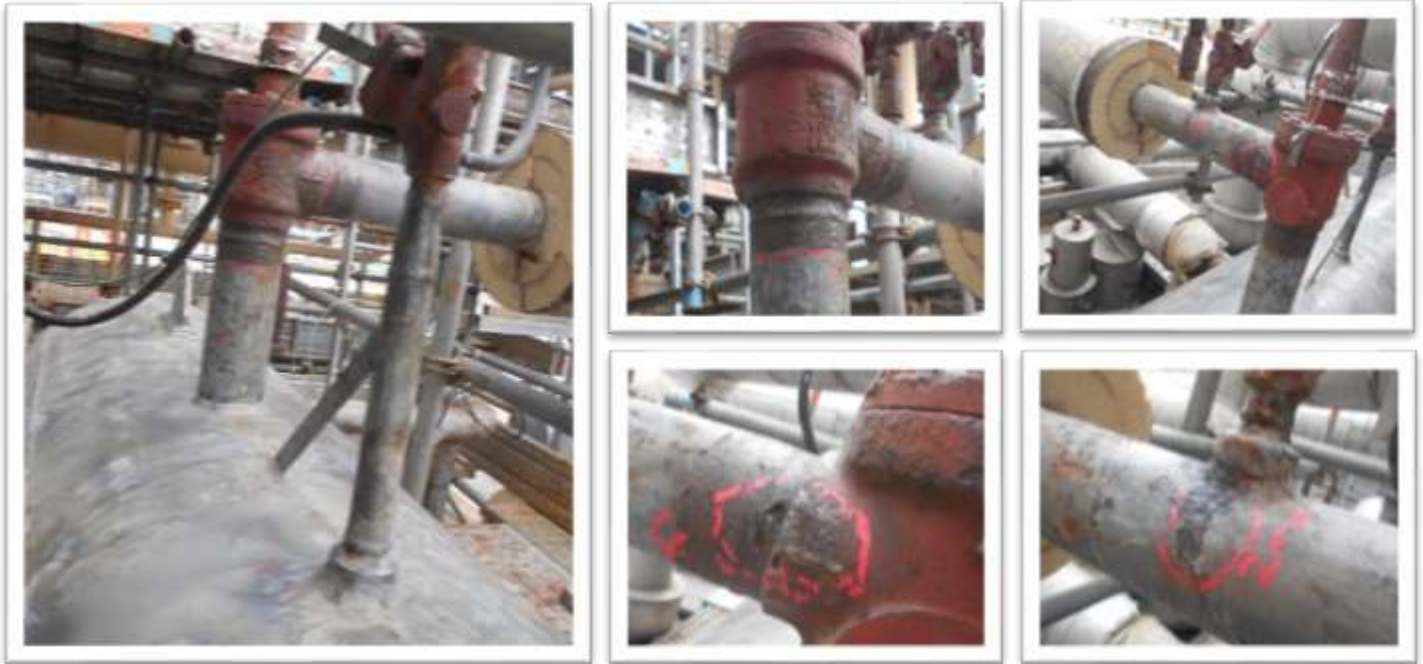
Fig 4: N3 Nozzle

Pitting corrosion was observed on N3 nozzle piping. Pitting is observed to be 4mm deep. Remaining thickness (1.49mm) is less than the minimum requirement of 2.0mm thickness (see Figure 1).

Circled in red is the extend of the pitting corrosion (+-2mm)

The occurrence of external corrosion in the straight pipe signifies compromised structural integrity. In consideration of the process service (N3), as well as the depth of the defect (approximately 2mm), this hazard poses a significant risk. Failure to resolve can potentially lead to loss of vital function.

To address the external corrosion (none through-wall defect), a carbon fibre composite laminate repair was applied to provide structural pressure containment as the wall loss experienced by the pipe negated the substrate's load-carrying capacity. The substrate surface preparation was done using the MBX bristle blaster to achieve a sufficient surface profile for adequate adhesion between the substrate and the laminate. The laminate was applied as a spiral wrap consisting of 4 layers for a total repair length of 380 mm and the appropriate cure cycle was executed. The installed Revowrap 110 composite repair system is fully qualified and compliant with ASME PCC-2 to meet the demands of petroleum, petrochemical and natural gas industries for various service types.
