# CASE STUDY

Carbontech Case study 026  
Co2 Skid Valve Flanges

Case Study Number CTCS:026	Design Pressure 24.13 Bar

Repair Summary CUI	Operating Pressure 19.65 BAR

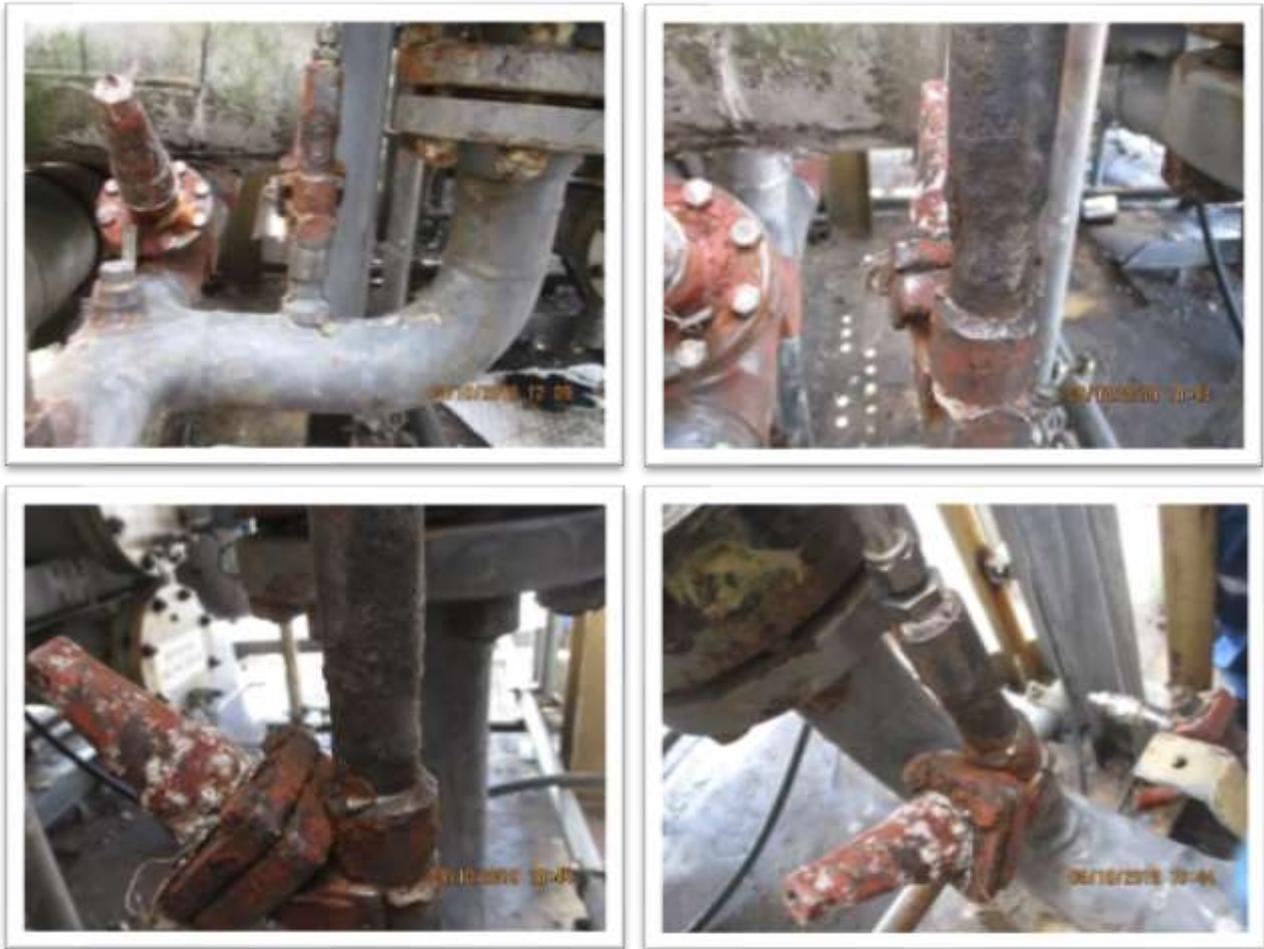
Fig 1: CO2 Nozzle

Severe corrosion was observed on vent line upon removal of insulation. (See Figure 1).

The occurrence of CUI (Corrosion under insulation) in the straight pipe signifies compromised structural integrity. In consideration of the process service (CO<sub>2</sub>), as well as the extensiveness of the defect, this hazard poses a significant risk. Failure to resolve can potentially lead to loss of vital function

To address the CUI (non-through-wall defect), a carbon fibre composite laminate repair was applied to provide structural pressure containment as the wall loss experienced by the pipe negated the substrate's load-carrying capacity. The substrate surface preparation consisted of manual intervention (Sand paper and filing) to achieve a sufficient surface profile for adequate adhesion between the substrate and the laminate. The laminate was applied as a spiral wrap consisting of 4 layers for a total repair length of 90 mm and the appropriate cure cycle was executed. The installed Revowrap 110 composite repair system is fully qualified and compliant with ASME PCC-2 to meet the demands of petroleum, petrochemical and natural gas industries for various service types. Figure 2 illustrates the application of the repair solution system and the completed wrap respectively

Surface Preparation achieved: SP3  
Product used: Revowrap 110  
Engineering calculations: ASME PCC2  
Layers used: 4 layers  
Post cured: Not Required
