CASE STUDY

Carbontech Case study 005
12" Straight-line Composite Wrap

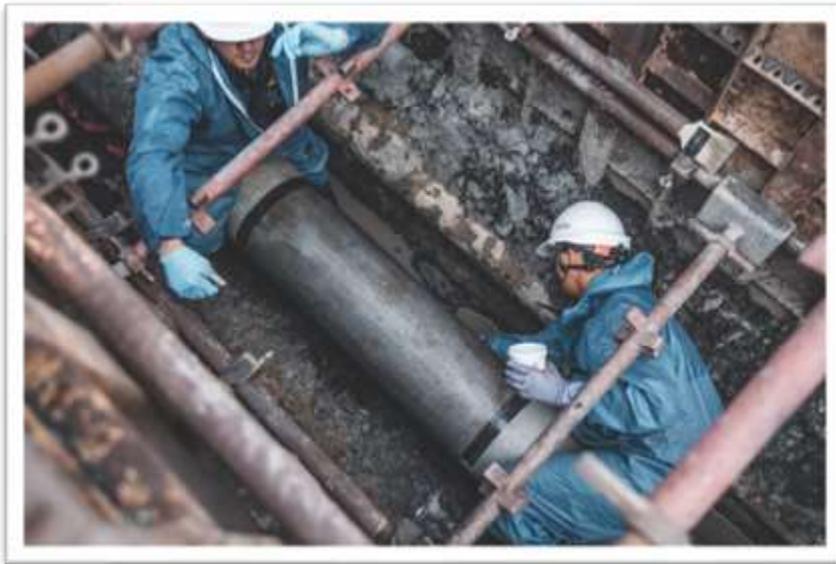
Upon inspection of a 12" white oil pipeline, a defect of approximately 823mm was detected in a straight section of the pipe caused by internal corrosion. In addition, the pipeline was located in soil below ground level, requiring excavation and scaffolding erection for a safe working environment (see Figure 1).

Figure 1: Surface preparation and primer application to the pipe straight section defect region (defect length of 823mm).

Surface Preparation achieved: SA2.5
Product used: Revowrap 110
Engineering calculations: ISO TS 24817
Layers used: 4 layers
Post cured: Not required.

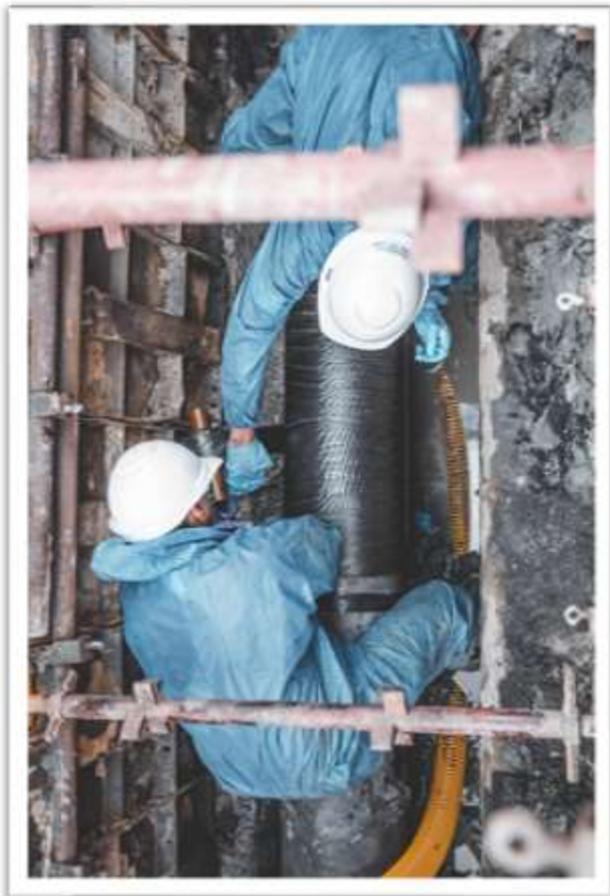
Figure 2: Carbon fibre composite laminate repair system application.

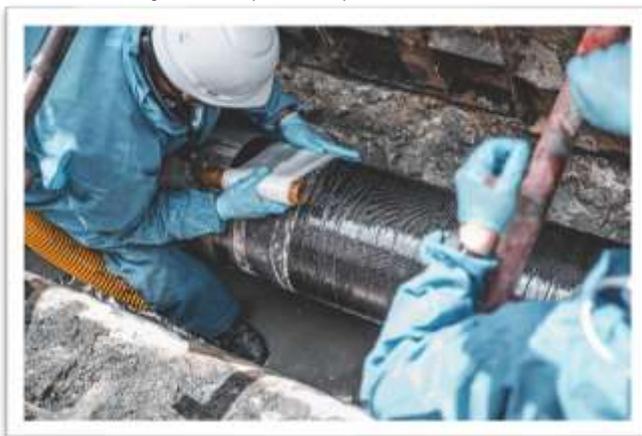
Figure 3: Peel-ply application as surface preparation for future adjacent repair wraps.

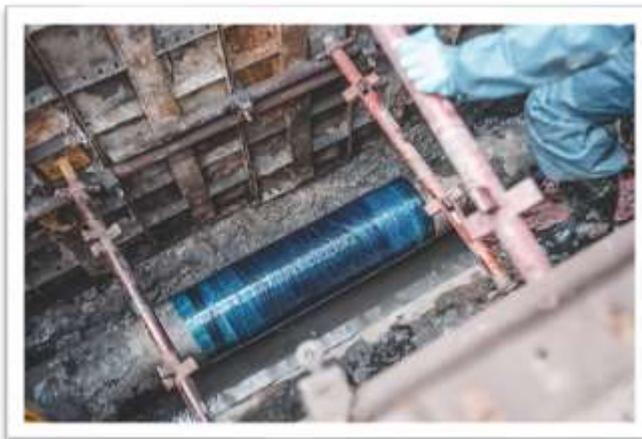
Figure 4: Application of compression film to uniformly distribute the resin by pressure.
