# CASE STUDY

Carbontech Case study 002  
12" Straight Pipe Repair

Case Study Number CT-CS:002	Design Pressure 34.7 BARg	 
 	Repair Summary 9 Meter Internal corrosion	Operating Pressure 5 Bar	 
 	Client Astron Energy Refinery	Design Temperature 48°C	 
 	Service Type White oil	Operating Temperature 25°C	 
 	Line Size 12 Inch	Base Material Carbon steel	 
 	Line Class NA

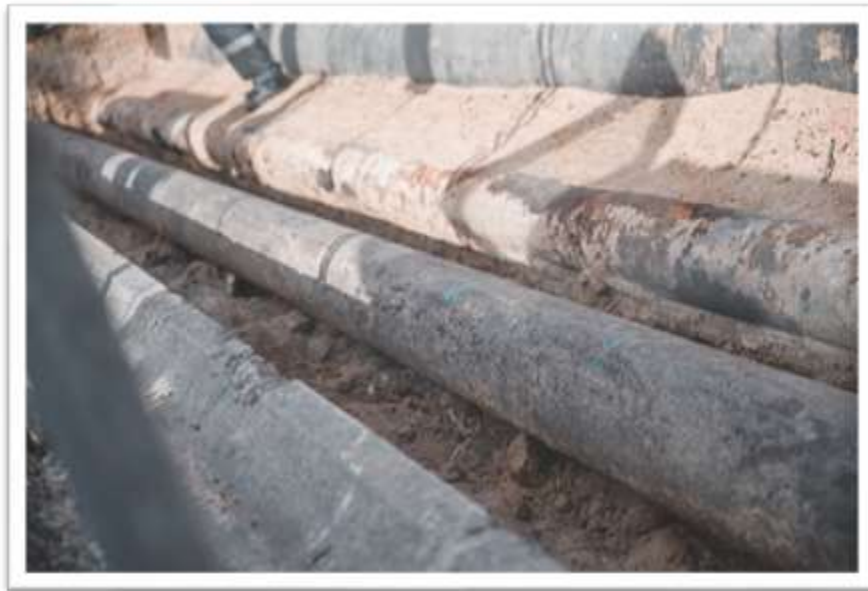
Upon inspection of a 12" crude oil pipeline, a defect of approximately 9000mm was detected in a straight section of the pipe caused by internal corrosion. The pipe was below ground level- requiring excavation (see **Error! Reference source not found.**).

Figure 1 Excavated white oil straight pipe section.

To address the internal corrosion (non-through-wall defect), a carbon fibre composite laminate repair was designed to provide structural pressure containment as the wall loss experienced by the pipe negated the substrate's load-carrying capacity. The substrate surface preparation consisted of sand blasting to achieve a sufficient surface profile for adequate adhesion between the substrate and the laminate.

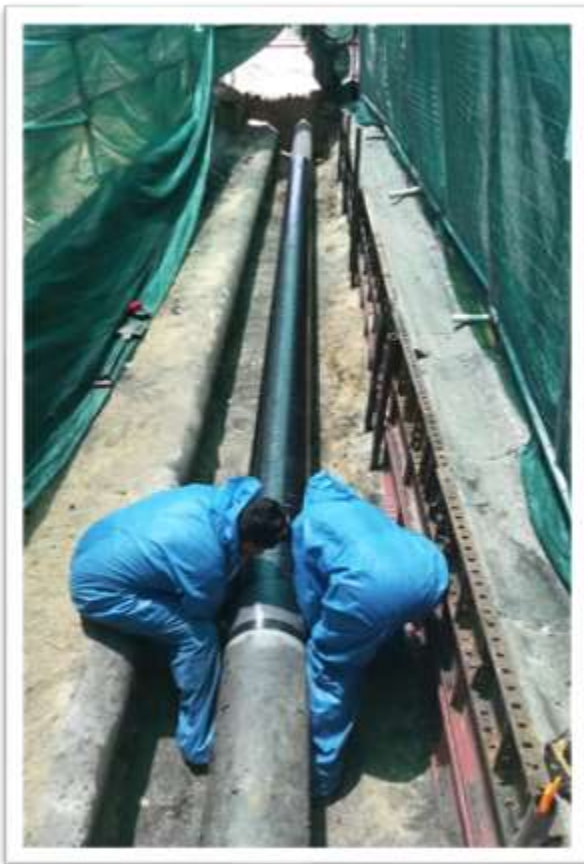
Figure 2: Application of the carbon fibre composite laminate repair system.

The laminate was applied as a spiral wrap consisting of 8 layers for a total repair length of 9255mm and the appropriate cure cycle was executed. The installed Revowrap 110 composite repair system is fully qualified and compliant with ASME PCC-2 to meet the demands of petroleum, petrochemical and natural gas industries for various service types. Figure 2 and Figure 3 illustrate the application of the repair solution system and the completed wrap respectively.

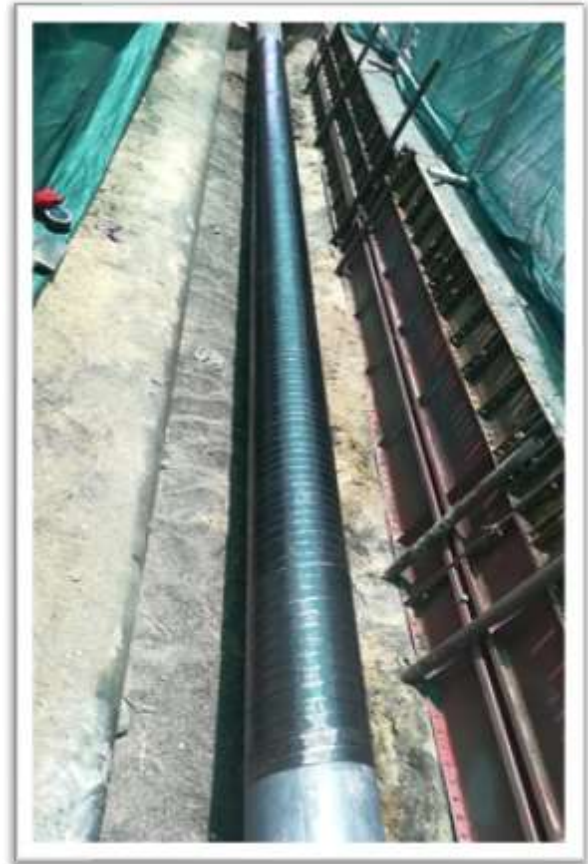
Figure 3: Completed carbon fibre composite laminate repair solution.
