Carbontech Case study 003
Corrosion on 6" Hydrocarbon Drain Lines

PROJECT DETAILS

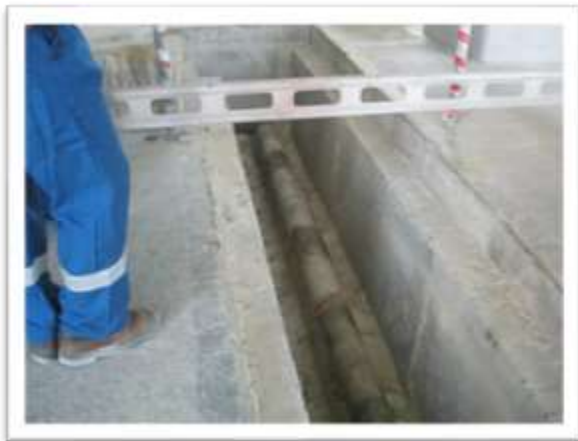
Figure. 1: Before

Non-destructive retests were performed in July and August, 2014. According to test results, corrosion rate was registered within 0.3-0.5 mm/year. Deterioration was not revealed within areas, where minimum thickness (2 – 3 mm when nominal thickness is 7.11 mm) had been registered earlier.

Corrosion is caused by deposits presence in system because of lack of permanent draining from the unit vessels (lack of flow intensity) and periodical caustic carry over.

There is risk of corrosion rate increasing and minor leaks occurring within areas where minimum thickness was registered.

Surface Preparation achieved: SA2.5
Product used: Revowrap 110
Engineering calculations: ISO TS 24817
Layers used: 4 layers
Post cured: Not required.

Entire section was the line was wrapped to ensure the continues safe use of the line

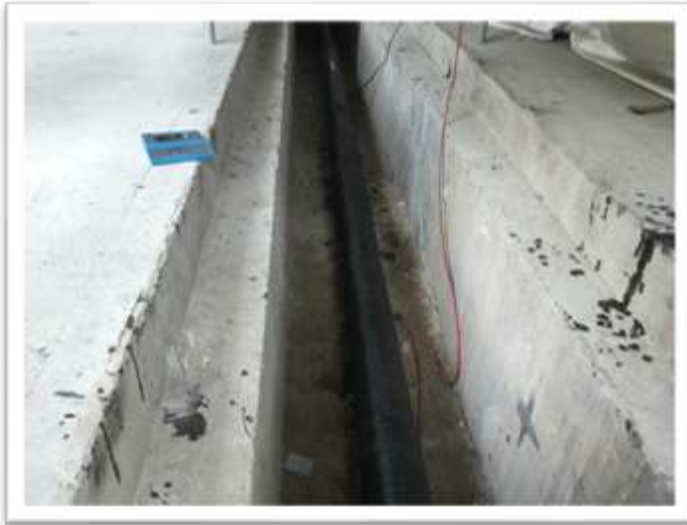
Figure 2: After

The composite repair system designed by Carbontech and satisfying the ASME PCC-2 standard was successfully installed. The corrosive nature of the process fluid and the length of the defect presented a challenge for the repair solution which was expertly addressed by Carbontech. As a non-through-wall defect repair, the laminate wrap provides structural integrity to the pipe in accordance with the required design specifications that will withstand the internal corrosion for the remainder of the required design lifetime.
